**RE: Area Plan Amendment - Hyundai Safety Testing and Investigation Laboratory**  
Hyundai America Technical Center, Inc.  
6800 Geddes Rd. Superior Charter Township, MI 48198  
IBI Group Project #: 134894

# PRELIMINARY GEOTECHNICAL EVALUATION REPORT

HATCI R&D CENTER | CRASH BUILDING & TEST TRACK  
SUPERIOR TOWNSHIP, MICHIGAN

SME Project Number: 087829.00  
November 11, 2021

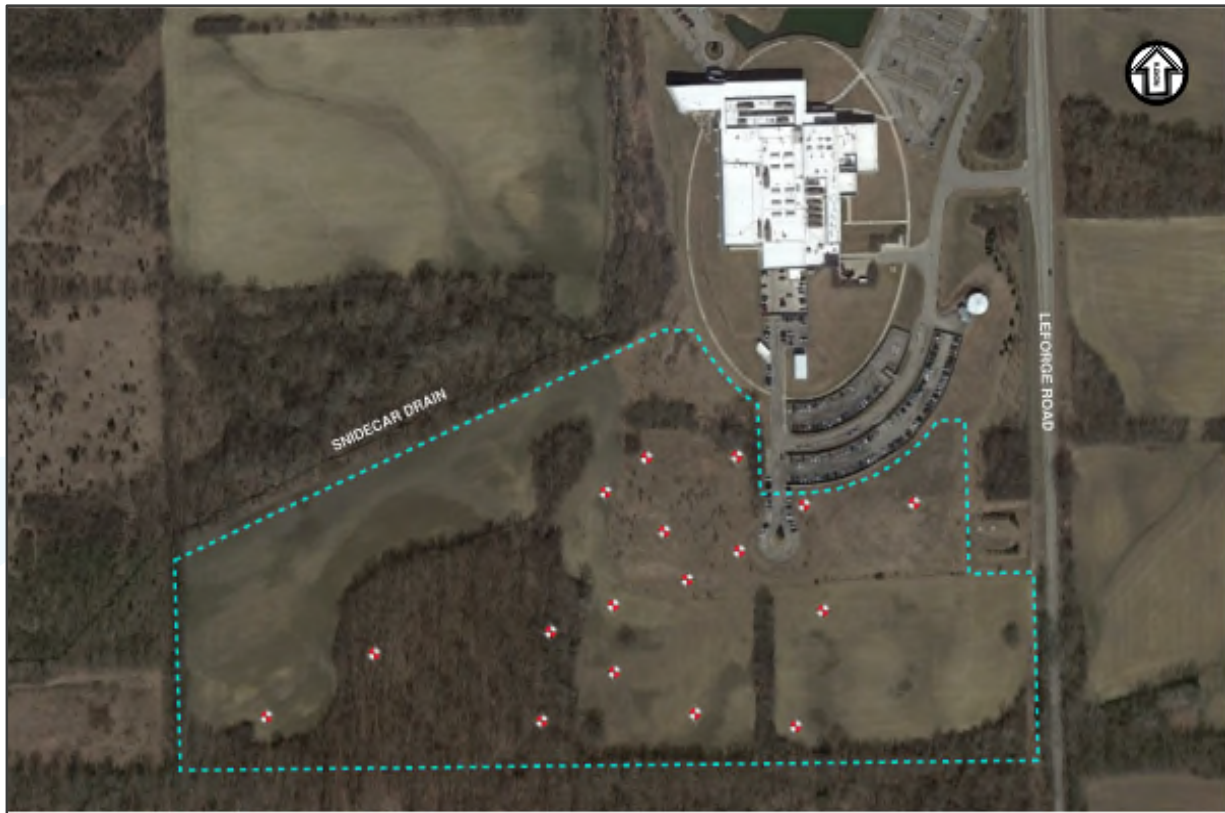
IMAGE 1 – SITE AERIAL DATED MARCH 19, 2021

The project site consists of the southern portion of the Hyundai-Kia America Technical Center, Inc. (HATCI) property located at 6800 Geddes Road in Superior Township, Michigan. The site area is generally covered with wild grass vegetation and contains densely wooded areas. The Snidecare Drain is located along the northwestern perimeter of the site and flows from northeast to southwest towards the Huron River (located about ½-mile away). The approximate location of the site is depicted on the Boring Location Diagram (Figure No.1), included in Appendix A. An aerial image depicting recent site conditions along with the soil borings performed for this project is provided below.

SME reviewed publicly available documents as part of our evaluation, including aerial photographs and topographic maps dating back to the 1900's. Based on our review, the site appears to have been utilized as agricultural farmland prior to construction of the current HATCI development in the mid-2000's. Relatively small structures (likely single-family houses and barns associated with the agricultural usage) were previously located along Leforge Road along the eastern site perimeter. We are not aware of any additional previous site development or usage (e.g., structures, utilities, etc.).

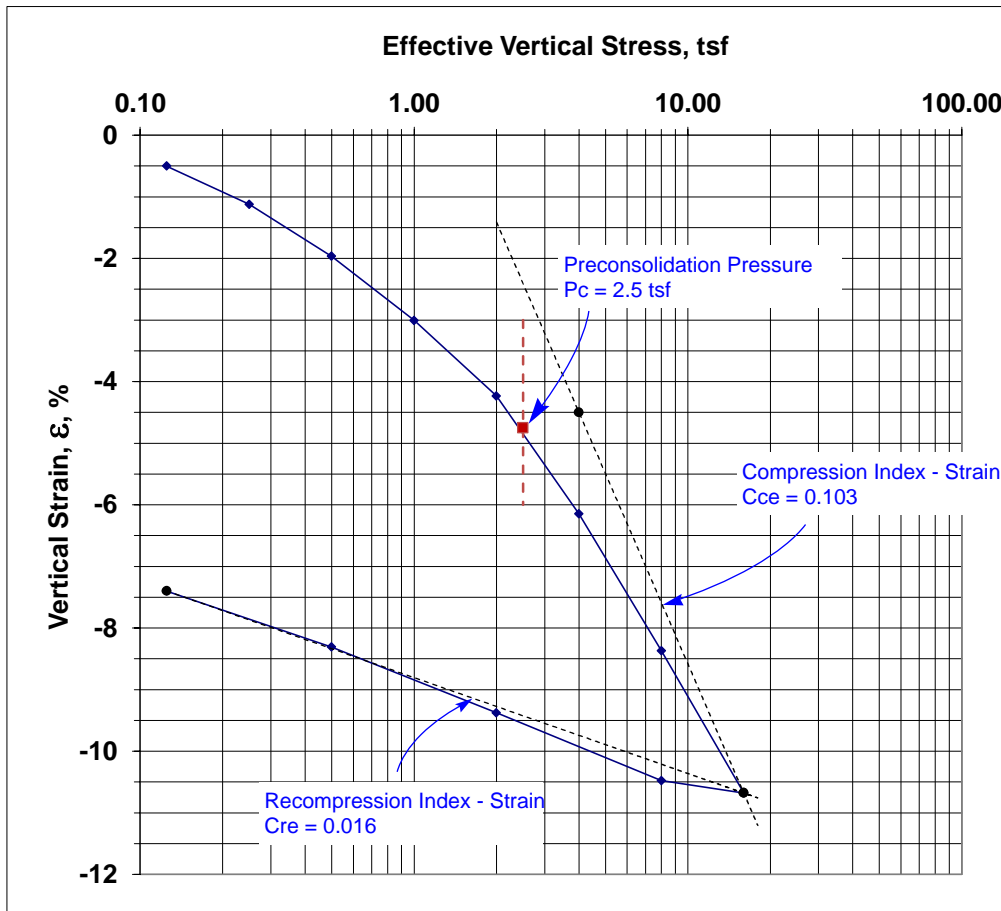
<b>Initial</b>	<b>Final</b>		
<b>Void Ratio, e</b>	0.35	0.26	<b>Overburden Pressure, <math>P_o</math>, tsf</b>	0.66
<b>Saturation, %</b>	112	100	<b>Preconsolidation Pressure, <math>P_c</math>, tsf</b>	2.50
<b>Water Content</b>	14.8	10.0	<b>Recompression Index – Strain, <math>C_{re}</math></b>	0.016
<b>Wet Unit Weight</b>	138.9	142.0	<b>Recompression Index, <math>C_r</math></b>	0.021
<b>Dry Unit Weight</b>	121.0	129.1	<b>Compression Index – Strain, <math>C_{ce}</math></b>	0.103
			<b>Compression Index, <math>C_c</math></b>	0.138
<b>% Heave</b>	---		<b>Coefficient of Consolidation @ _ tsf, <math>c_v</math></b>	---
<b>Swell Pressure</b>	---		<b>Coefficient of Consolidation @ _ tsf, <math>c_v</math></b>	---

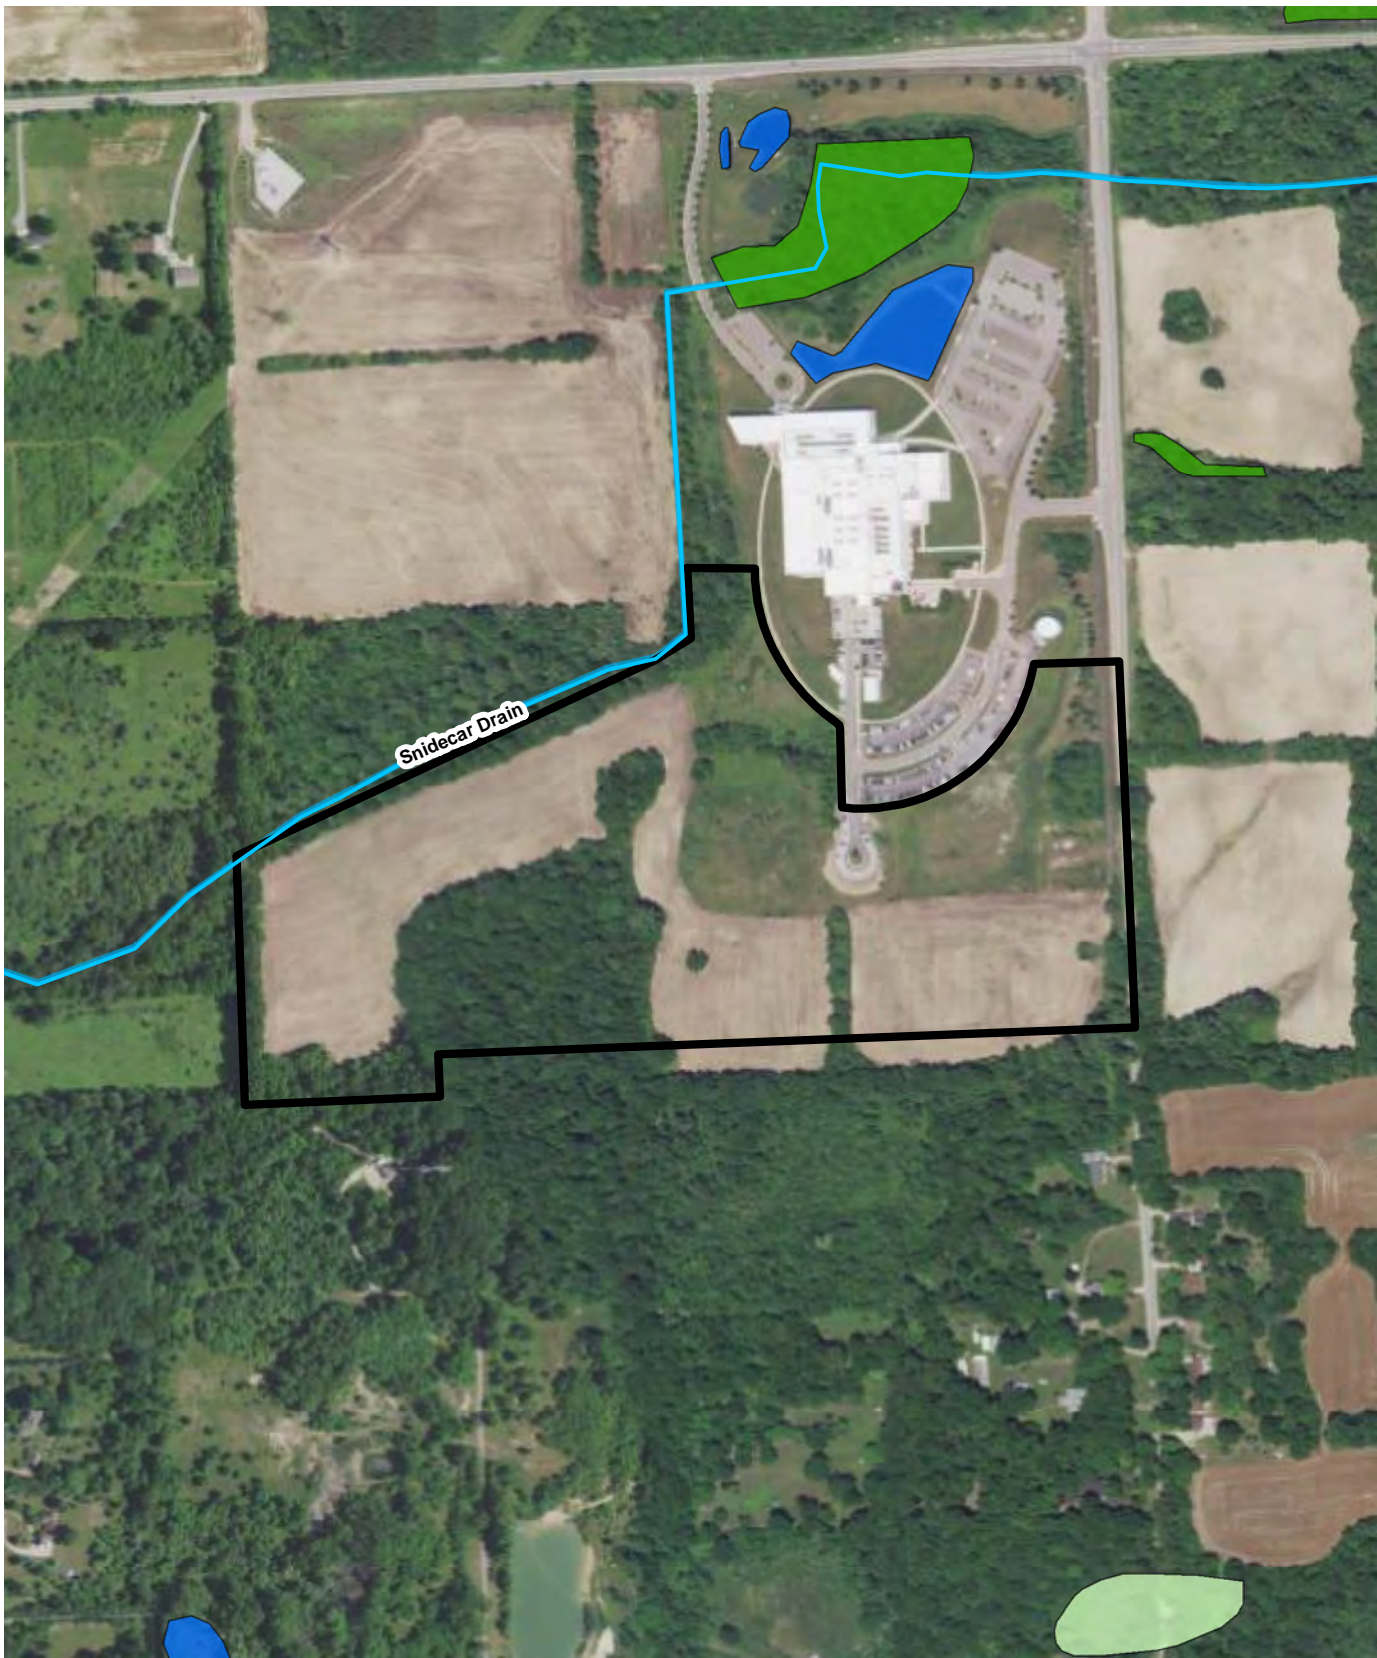
**Legend**

- Canal or Ditch
- Freshwater Emergent Wetland
- Freshwater Forested/Shrub Wetland
- Freshwater Pond
- Riverine
- Project Area

During the site reconnaissance, six (6) wetlands (wetlands W1A, W2A, W3A, W4A, W5A, and W6A) were identified within the Project Area and are shown on the Wetland Delineation Map (**Appendix A: Figure 7**). USACE Midwest Region wetland data sheets are provided in **Appendix B**. Wetlands identified had a predominance of hydrophytic vegetation, hydric soils, and observed hydrological characteristics.

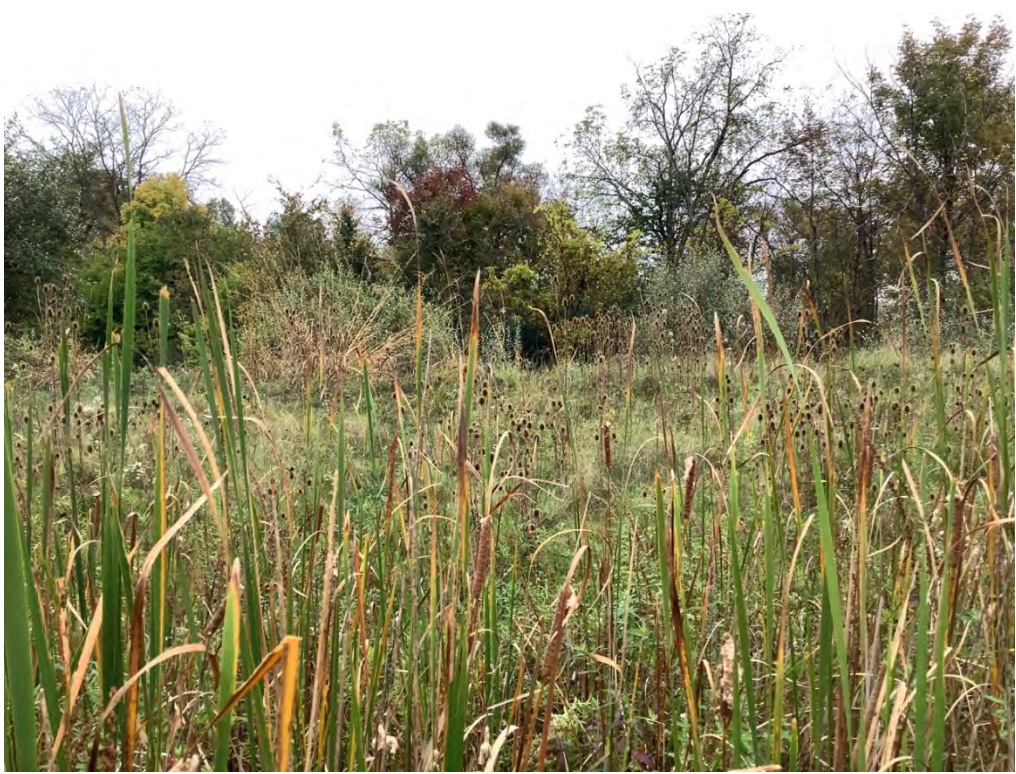
<b>Client Name:</b> IBI Group		<b>Site Location:</b> Washtenaw County, Michigan	<b>Project No.</b> 210731
<b>Photo No.</b> 3	<b>Date:</b> 10/06/2021

<b>Direction Photo Taken:</b> West			
<b>Description:</b> The photo is a view of wetland W2A, located in the north-central portion of the Project Area.

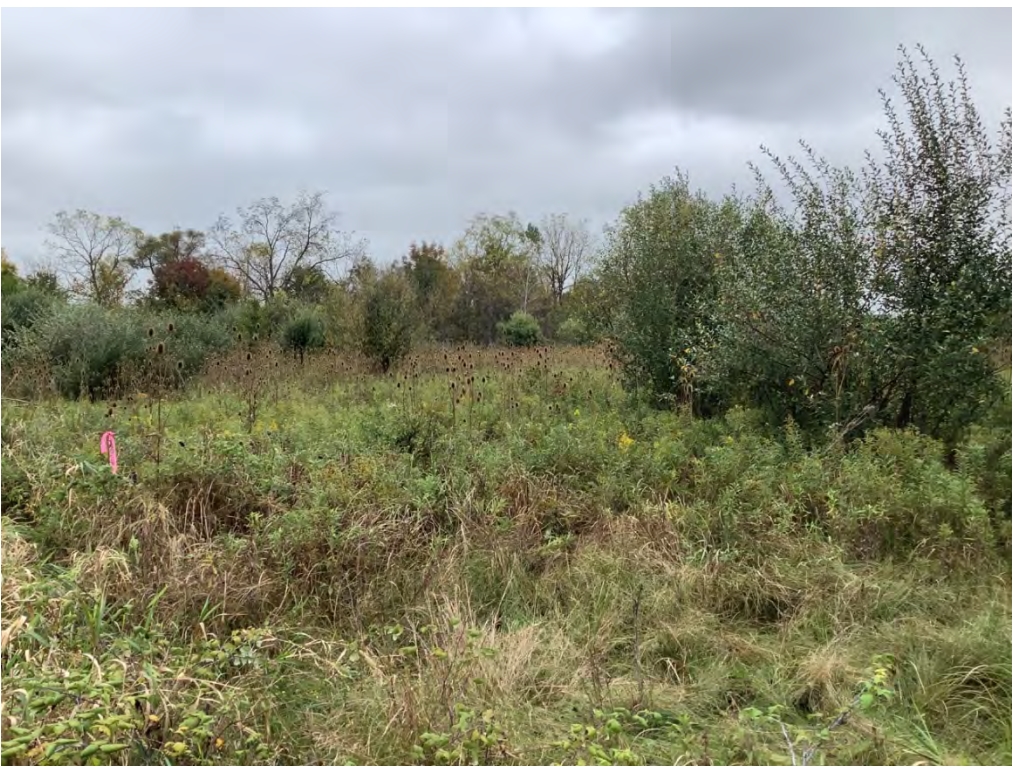
<b>Client Name:</b> IBI Group		<b>Site Location:</b> Washtenaw County, Michigan	<b>Project No.</b> 210731
<b>Photo No.</b> 5	<b>Date:</b> 10/06/2021

<b>Direction Photo Taken:</b> North			
<b>Description:</b> This photo was taken of wetland W4A.

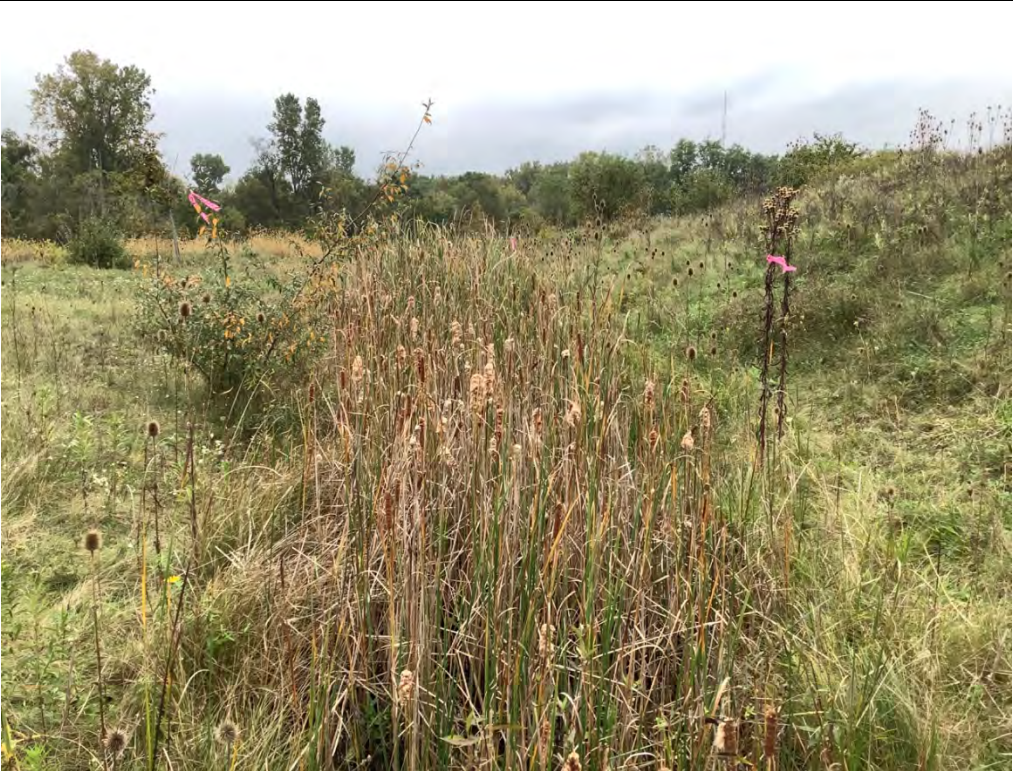
<b>Photo No.</b> 6	<b>Date:</b> 10/06/2021

<b>Direction Photo Taken:</b> South			
<b>Description:</b> This photo was taken of wetland W5A, looking south.

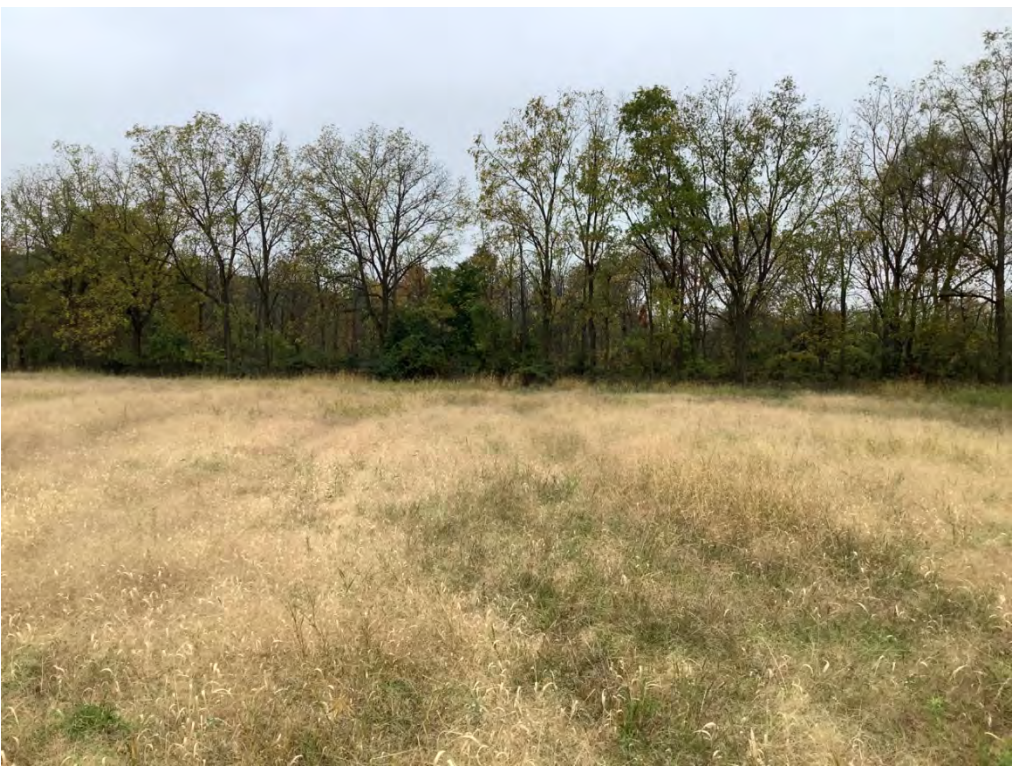
<b>Client Name:</b> IBI Group		<b>Site Location:</b> Washtenaw County, Michigan	<b>Project No.</b> 210731
<b>Photo No.</b> 7	<b>Date:</b> 10/06/2021

<b>Direction Photo Taken:</b> West			
<b>Description:</b> This photo shows the upland area (W1A-UPL) near wetland W1A.

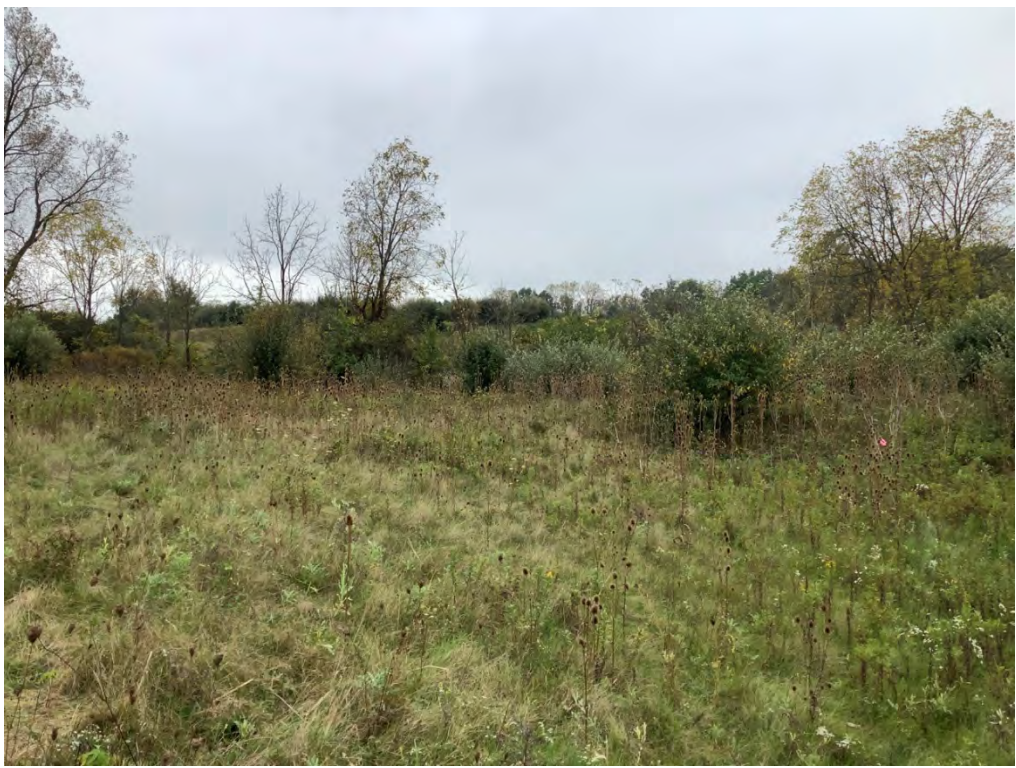
<b>Client Name:</b> IBI Group		<b>Site Location:</b> Washtenaw County, Michigan	<b>Project No.</b> 210731
<b>Photo No.</b> <b>9</b>	<b>Date:</b> 10/06/2021

<b>Direction Photo Taken:</b> South			
<b>Description:</b> This photo was taken of the grassland upland area (W2A-UPL) near wetland W2A.

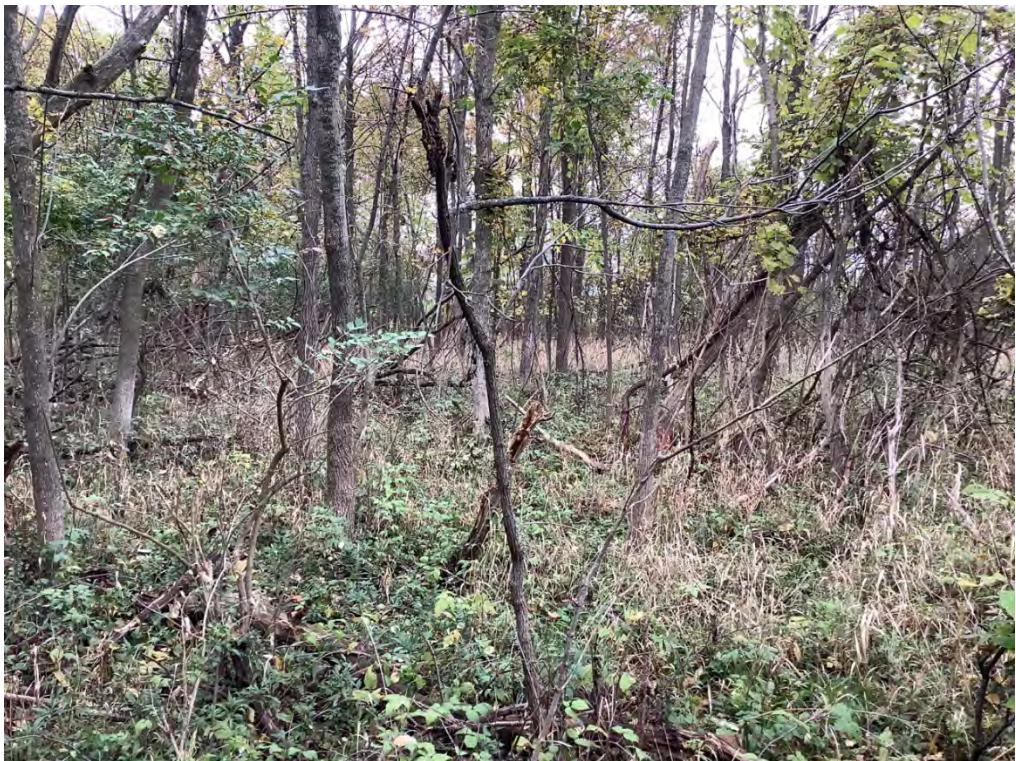
<b>Photo No.</b> <b>10</b>	<b>Date:</b> 10/06/2021

<b>Direction Photo Taken:</b> North		
<b>Description:</b> This photo shows the forested upland area (W3A-UPL) near wetland W3A.

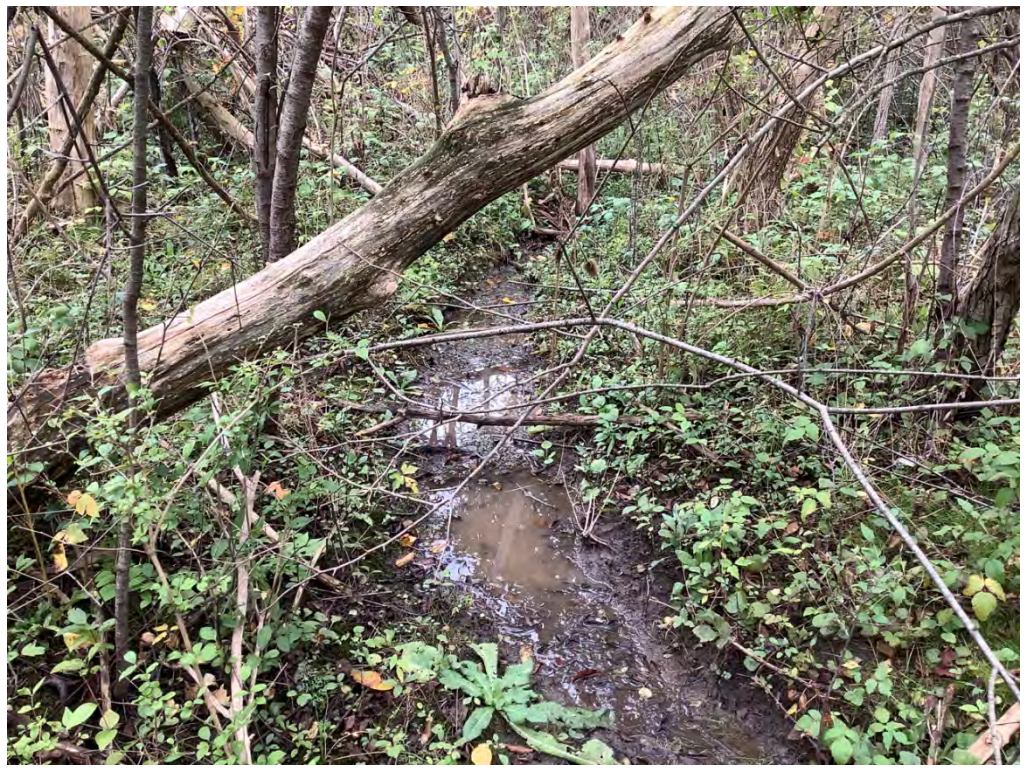
**Description:**  
This photo was taken of stream S2A.
